USACERL Technical Report E-91/08
July 1991

Evaluation of Central Heating Plant at Rickenbacker Air National Guard Base

by
Martin J. Savoie
John Gostich
J.W. Chappell
John Richards

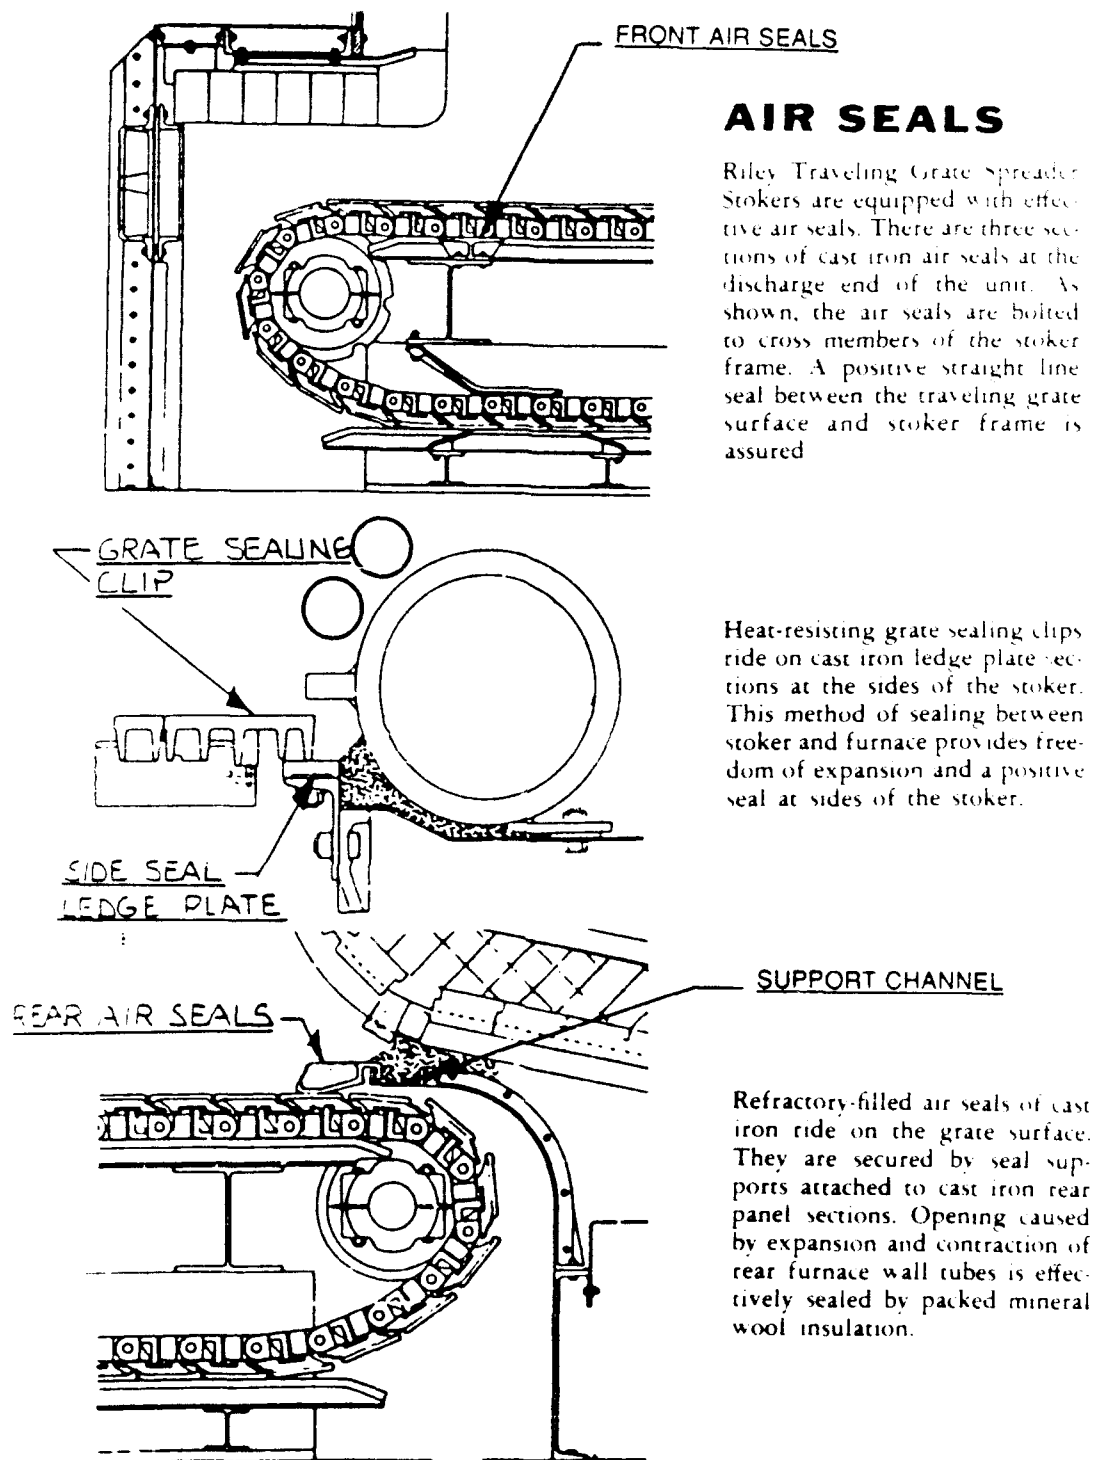
Figure 8. Riley stoker grate seals.

A typical repair item for all four boilers was the rear grate seals. On boiler No. 8, a Detroit Stoker, these are called the rear grate seal tuyeres (Figure 7). On boilers Nos. 4, 6, and 7, Riley Stokers, they are called rear grate refractory-filled air seals (Figure 8). These seals prevent air leakage at the rear of the grate surface and, in conjunction with the front and side seals, maintain minimum excess air in the furnace.

Boiler No. 8 - Detroit Spreader Stoker	<ul style="list-style-type: none"> ** Replace eight rear grate seal tuyeres ** Replace all feeder blades on Feeders Nos. 1 and 2 (left to right facing boiler front) ** Replace all feeder plates and spilling plates
Boiler No. 7 - Riley Spreader Stoker	<ul style="list-style-type: none"> ** Replace worn rear grate refractory
Boiler No. 6 - Riley Spreader Stoker	<ul style="list-style-type: none"> ** Replace refractory on rear grate air seals
Boiler No. 4 - Riley Spreader Stoker	<ul style="list-style-type: none"> * All refractory filled air seals including support channels need to be replaced * Approximately 70% of skid shoes need replacement. * Replace front air seals cut by worn skid shoes. * Replace drive shaft and idler shaft bearings * Drive shaft sprockets should be reversed to obtain new bearing surface, or replaced * Two feeders need new arm pins and rollers for a correct pusher box stroke * Replace deflector tuyeres on all three feeders

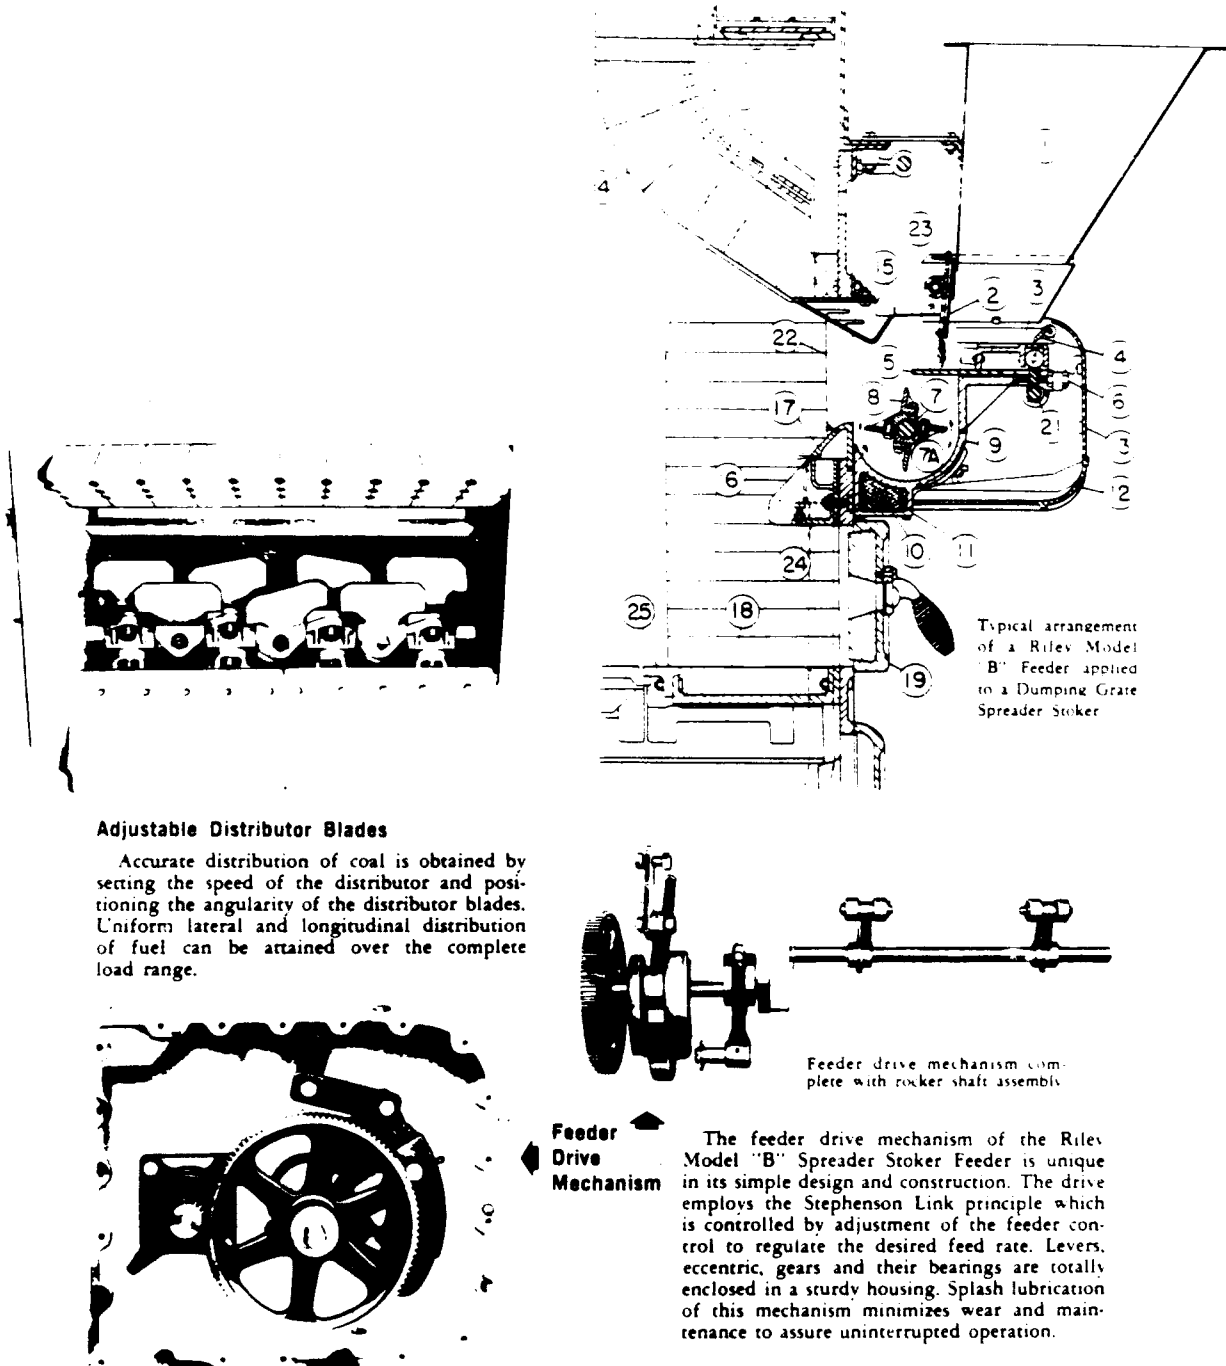
Figure 11. Riley stoker feeder assembly.

The feeder plates and blades (Figure 9) need to be replaced on boiler No. 8. Boiler No. 4 needed the most repairs, requiring repair to the skid shoes, drive shaft and idler shaft bearings, drive shaft sprockets (Figure 10), feeder arms (Figure 11) and deflector tuyeres (Figure 7). Table 3 summarizes the recommended repairs for each of the stokers.

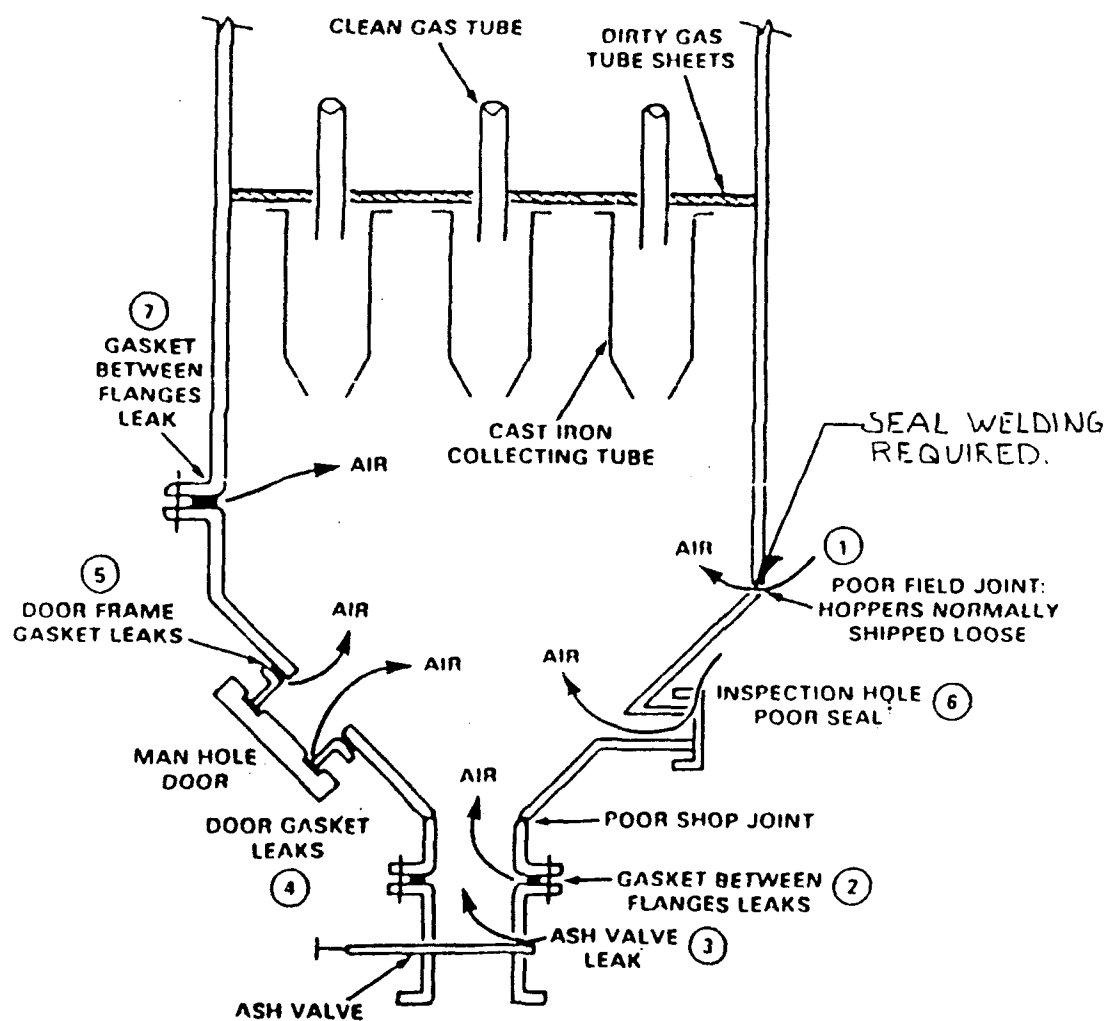
Figure 17. Collector hopper and dirty gas tube sheet seal.

tubes were badly worn by erosion, all the tubes were replaced and resealed. The collector hopper and dirty gas tube sheet also required seal welding to eliminate air infiltration (Figures 17 and 18). Maintenance recommendations for the common multicyclone collectors (repaired prior to testing) were:

1. Power wash the collector inlet and outlet areas prior to inspection and leak testing.
2. Sixty-two cast iron collecting tubes were badly worn from fly ash erosion, 16 of them having holes. All 108 tubes should be replaced.
3. Seal the weld collector hopper and dirty gas tube sheet.

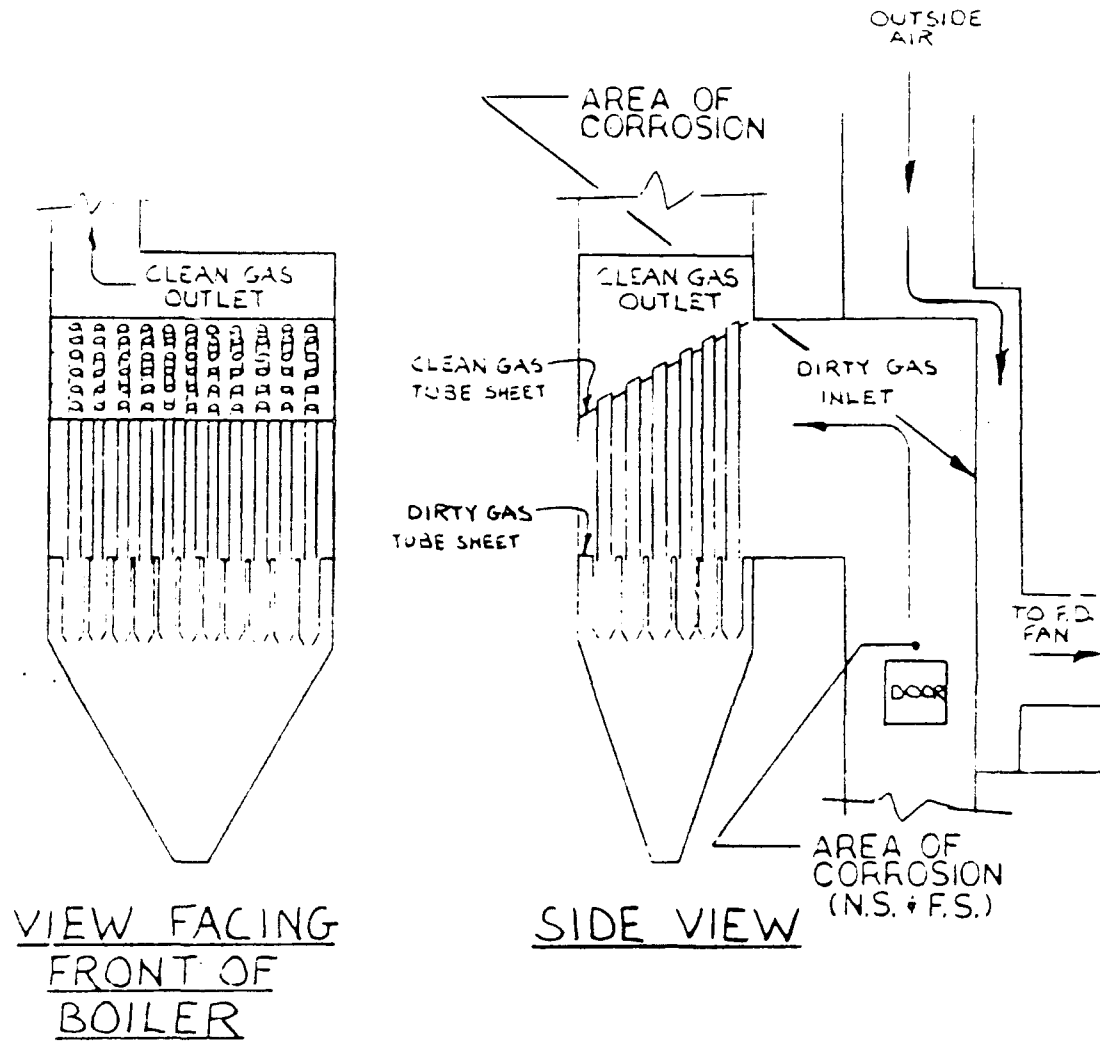
SKETCH NO. 4A

The corroded areas of the dirty gas inlet breeching walls of Boilers No. 7, 6, and 4 were other sources of air infiltration into the flue gas flow. A typical breeching arrangement for Boilers No. 7, 6, and 4 is shown in Figure 14, with the corroded areas noted. Corrosion most likely occurred during light heating loads and during the winter heating season where the outside air that is supplied to the forced draft fan cools the surrounding duct to the dew point temperature. Although the flue gas directly in contact with the duct is below the dew point, the average flue gas temperature to the mechanical dust collector inlet was probably above the dew point temperature, since there were no signs of plugged inlet ramps.

BOILERS NO. 7, 6, & 4
MECHANICAL DUST
COLLECTOR

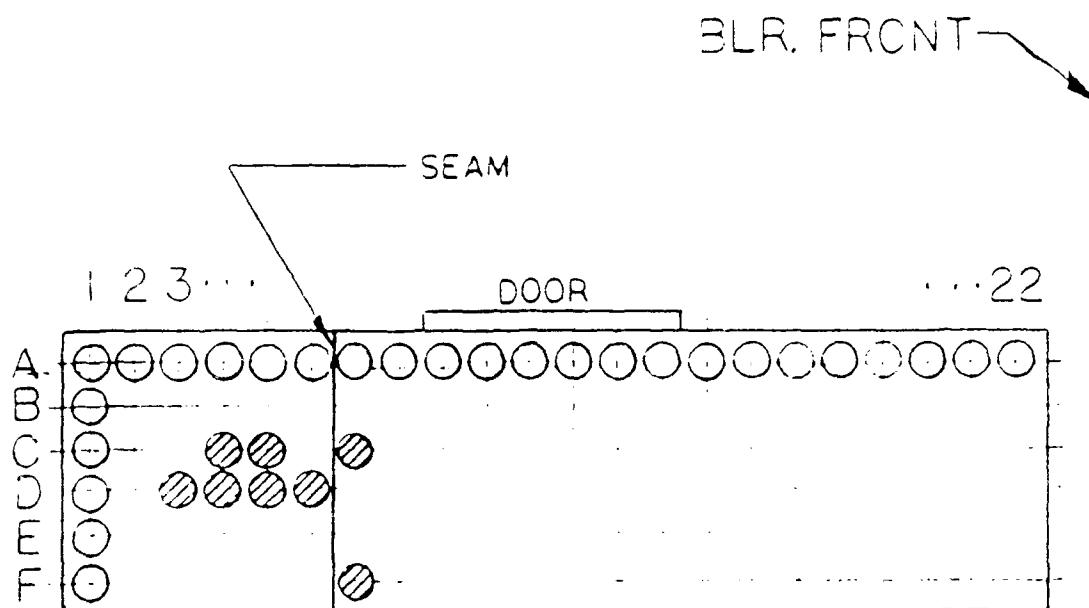
VIEW LOOKING DOWN TUBE SHEET LAYOUT

TUBES THAT ARE WORN:
(NO REPLACEMENT REQUIRED)
